re: Protecting Safety and Beauty at Western Gateway Bridge

FIX THE WESTERN GATEWAY BRIDGE: GIVE US BACK Our SCENIC VIEWS and SIDEWALK SAFETY GUARDRAILS

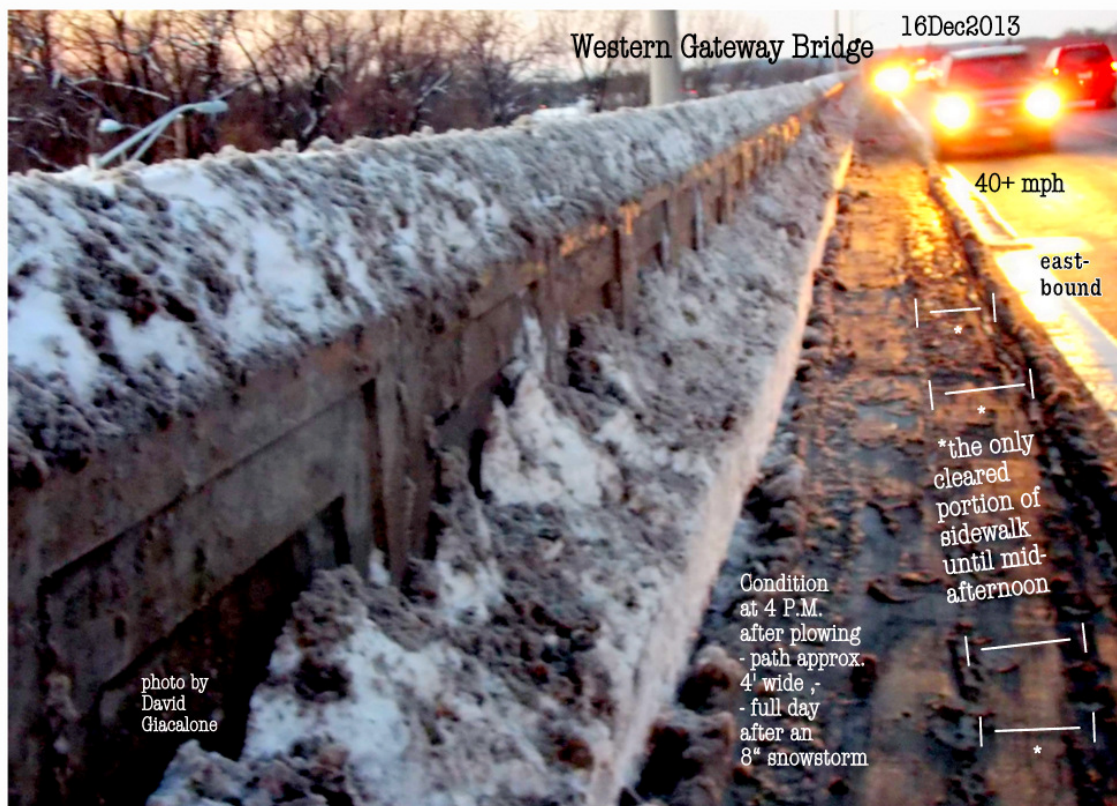
One more issue of sidewalk safety was demonstrated just this week at WGB. Snow plows pushed snow from the weekend storm up against the new cement parapet. As a result, at 3 PM on Monday, the usable part of the new 5'2" sidewalk was less than two feet wide, and slippery, when I saw a young man trying to reach Scotia on foot. Attachment 2 is a photograph that I took at 4 PM on Monday, as a plow had just completed its task of removing the piled snow from that sidewalk. As the photo shows, a significant part of the sidewalk was still obstructed by the snow piled along the parapet, and the "cleared" part has clumps and ridges of snow and ice that left the sidewalk treacherous. Of course, the roadway was also slippery. The 2008 NYDOT Bridge Manual notes (at page 6-6):
